Liquid-Erosion Failures

Frederick G. Hammitt, Department of Mechanical Engineering and Applied Mechanics, University of Michigan
Frank J. Heymann, Westinghouse Electric Corporation

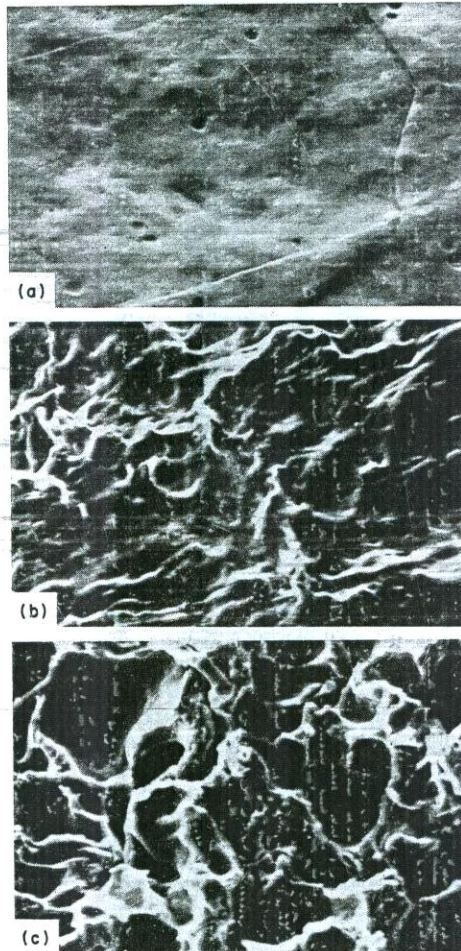
Fig. 4 Scanning electron micrographs of a surface of polycrystalline nickel damaged by exposure to intense cavitation in a vibratory test at 20 kHz

(a) Shallow craters that formed on the surface after exposure for 5 s. (b) More widespread and deeper attack after exposure for 10 min. (c) Fracture of ridges between deep pits after exposure for 2 h. Source: Ref 4

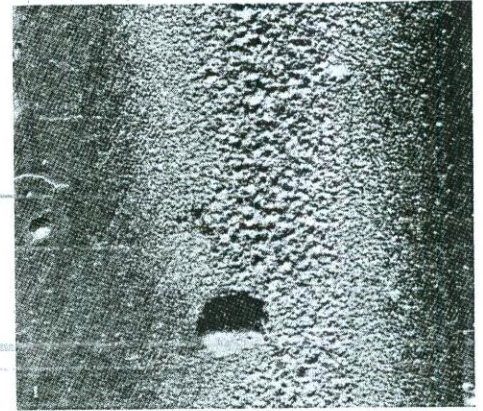
Fig. 5 Pitted surface of a stainless steel pump component damaged by exposure to cavitating mercury

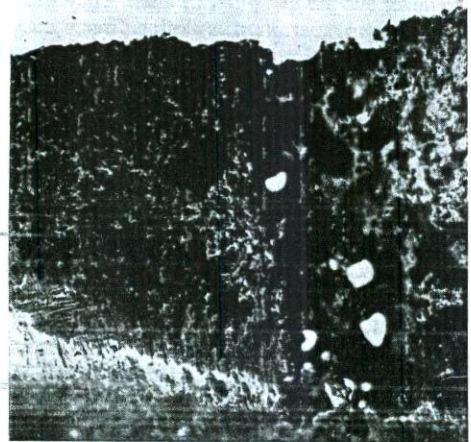
Fig. 8 Leading edge of a series 400 stainless steel impeller for a boiler feed pump showing deep local damage caused by cavitation erosion

Erosion damage typically appears as a pitted or honeycomblike region, as shown in Fig. 8 on a stainless steel impeller blade from a boiler feed pump. In some instances, erosion damage results in an appreciable loss of metal. For example, the propellers of high-speed ocean liners have sustained sufficient loss of metal in a single crossing of the Atlantic to require replacement.

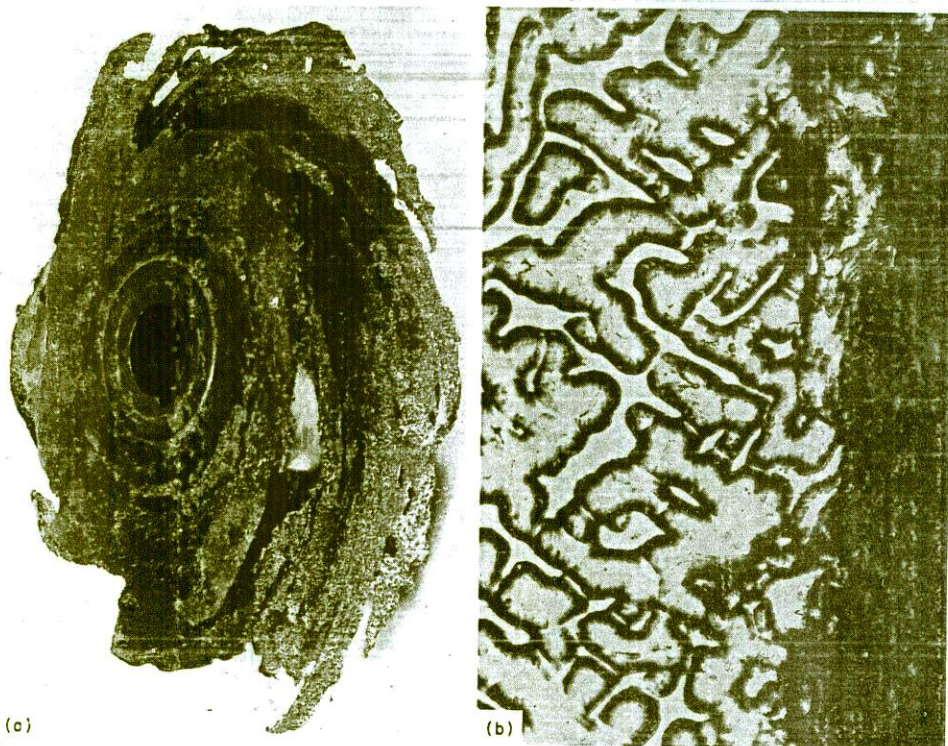
Example 1: Failure of a Bronze Pump Impeller by Cavitation Damage. Figure 9(a) shows the impeller from one of two water pumps that were taken out of service because of greatly reduced output. Both impellers showed

considerable material loss over all the interior and exterior surfaces. The pumps drew water from an open tank through a standpipe. Several similar water pumps were operating under almost the same conditions with no observed failures.

Investigation. Visual examination of the impellers disclosed that the interior surfaces were extremely clean but were pockmarked over the entire area. The flange face on the suction side and the surfaces adjacent to those where material was missing showed evidence of cold work.

Micrographs of sections through the damaged surfaces showed a layer of distorted metal grains (Fig. 9b). At higher magnification, slip lines were visible, indicating that severe cold work had occurred at the surface. There was no evidence of intergranular attack or dezincification.

The clean, pockmarked, severely eroded surfaces of the impellers are characteristic of cavitation damage. In this instance, cavitation damage could have been the result either of a turbulent flow pattern caused by the movement of the impellers in the liquid or of excessive air in the system because the water in the supply tank was low or because air had been drawn through a pump seal. Further investigation revealed that considerable quantities of air were

being drawn into the system when the water in the supply tank was allowed to drop to a low level.

Conclusions. Cavitation erosion caused the metal removal and the microstructural damage evidenced by a shallow layer of severely worked grains at the damaged surface. Cavitation was induced when a low level of water in the supply tank allowed large quantities of air to be drawn into the standpipe along with the water. However, air injection into the bubble-collapse region is sometimes used to reduce damage by cushioning bubble collapse (Ref 1, 2).

Fig. 9 Water-pump impeller with considerable loss of material from cavitation damage

(a) Photograph of cast bronze impeller. (b) Micrographs of an etched section from the impeller showing a layer of distorted metal grains at the surface subjected to cavitation. 100×

Corrective Measures. A water-level control was added to the piping system to maintain a sufficient head of water at the standpipe, and air was excluded from the pump inlet. No further failures occurred.

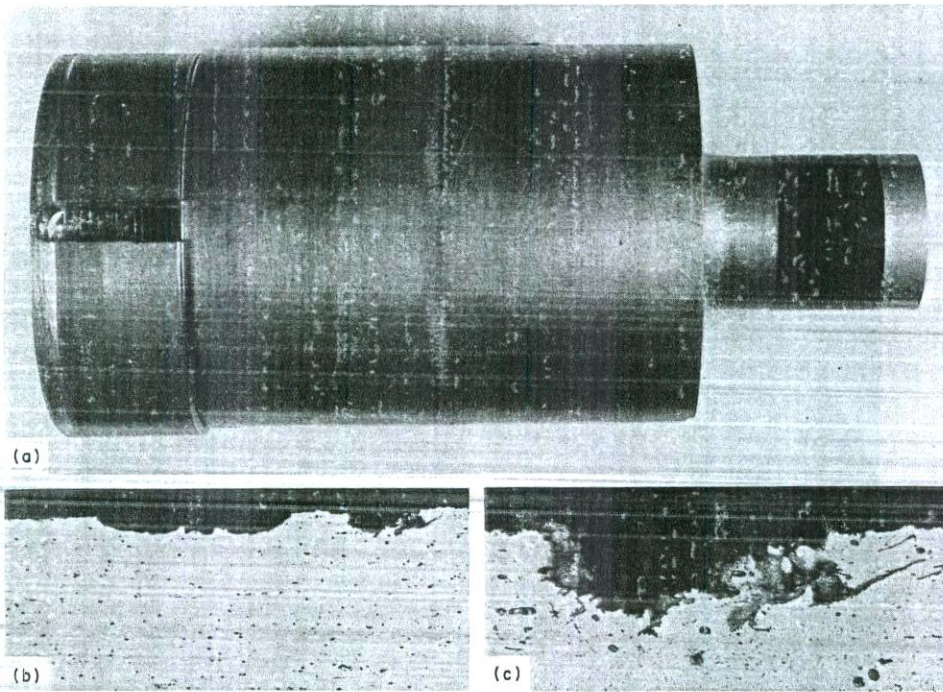
Fig. 10 Aluminum alloy 6061-T6 combustion chamber damaged by cavitation erosion

The chamber rotated in water at moderate speed. (a) Overall view of the chamber. (b) and (c) Micrographs of cross sections of the chamber wall showing typical cavitation damage. 100 and 500 \times , respectively

Conclusions. As a result of improper heat treatment, the combustion-chamber material was too soft for successful use in this application. Because even the external surface of the shank, which could not be heated above about 95 $^{\circ}C$ (200 $^{\circ}F$) in use, was just as soft and showed the same distribution of Mg_2Si as the hottest portion of the combustion chamber, overheating in service was eliminated as a possible cause of the observed low hardness.

Misalignment of the combustion chamber and one or both of the mating parts, to which the softness of the chamber material could have been a contributory factor, resulted in eccentric rotation and the excessive vibration that caused malfunction of the assembly. Contact against a surrounding member then caused the exten-

The operating characteristics of the defective combustion chamber were not sufficiently understood to explain the mechanism by which the cavitation erosion was concentrated at the two bands observed. Irregularities in the housing around the combustion chamber and temperature variation relating to the combustion pattern in the chamber were considered to be possible contributing factors to localization of the cavitation erosion.

Recommendations. The adoption of inspection procedures to ensure that the specified properties of aluminum alloy 6061-T6 were obtained and that the combustion chamber and adjacent components were aligned within specified tolerances was recommended to prevent future occurrences of this type of failure on these assemblies. In a similar situation, consideration should also be given to raising the pressure in the coolant in order to suppress the formation of cavitation bubbles.

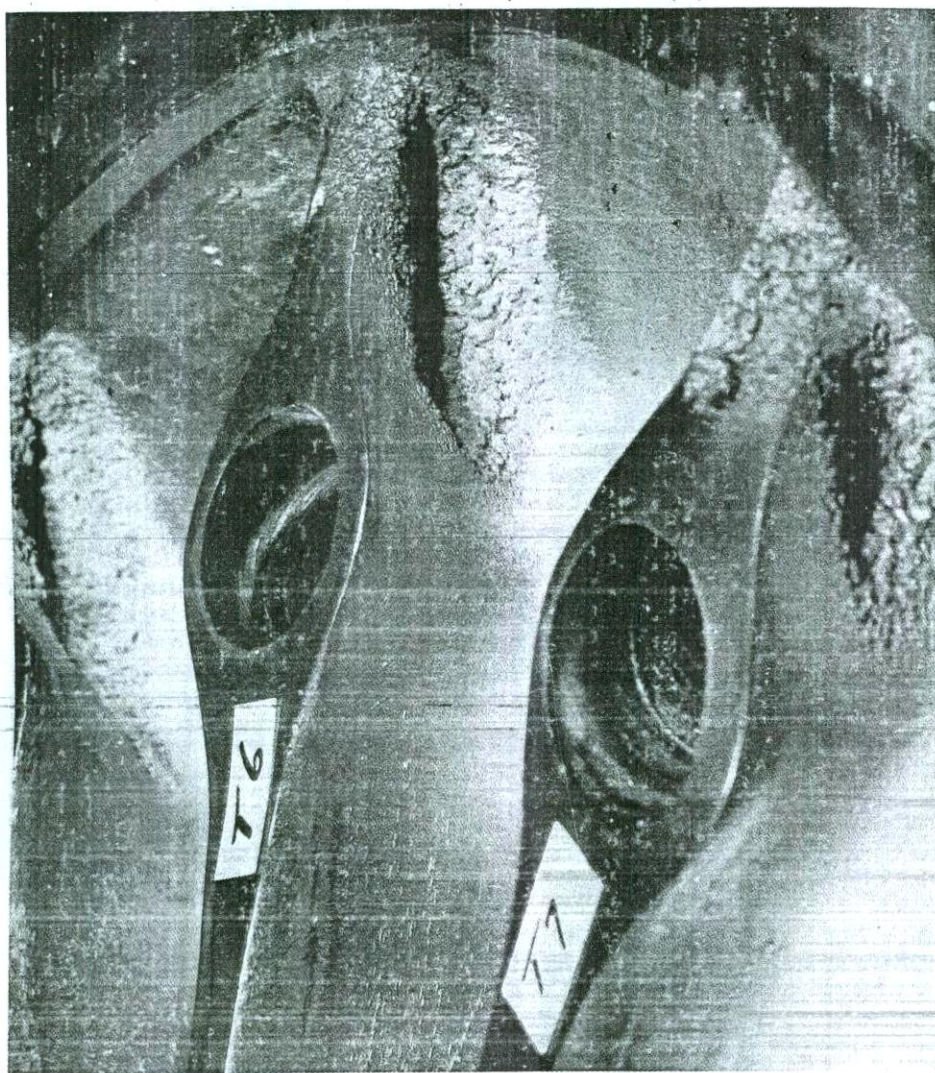
This dynamometer, designed to absorb up to 51 MW (69 000 hp) at 3670 rpm, constituted an extrapolation of previous design practices and experience. It was subject to severe erosion of the stator (Fig. 11) after relatively short operating times and initially required replacement of the stator after each test program. Up to 60 cm^3 (3.7 in.³) of material was lost from each vane. However, even such severe erosion reduced its power-absorption capacity only slightly.

Investigation. The damage was clearly erosion by liquids, but it could not be firmly established—nor was there agreement in speculation—whether it was caused by cavitation or by liquid impact. It could be argued that cavitation is induced in the recirculating flow by the rotor vanes (acting as obstructions) or by the discontinuity of the water-discharge slot. It could also be argued that the acceleration forced on the water in the rotor, which makes the flow hug one side of each rotor pocket, causes a rotating discontinuous pattern of streams to emerge from the rotor, which then produces discrete liquid impacts on the stator vanes. A dynamic pressure transducer, installed in the working compartment, did show strong peaks at rotor vane frequency. Injection of air bubbles did not result in a reduction of fluctuation pressures in the working compartments, although this is a recognized method of controlling cavitation. Minor changes in geometry had little effect on erosion.

Fig. 11 Vanes of a dynamometer stator damaged by liquid erosion

Recommendations. The remedy for this machine was a material substitution. The original stator casting material was changed to an Mo-13Cr-4Ni stainless steel (ACI designation CA-6NM). The original casting material has a normalized erosion resistance, N_e , of about 1; the CA-6NM, an N_e of 2 to 2.5. Consideration was given to Stellite cladding, but the CA-6NM

stators, while not erosion free, operated satisfactorily until the test facility was decommissioned. The dynamometer manufacturer has since radically redesigned its line of high-speed high-power dynamometers, with reduction of susceptibility to erosion (and to erosion-producing conditions) as one of the objectives.

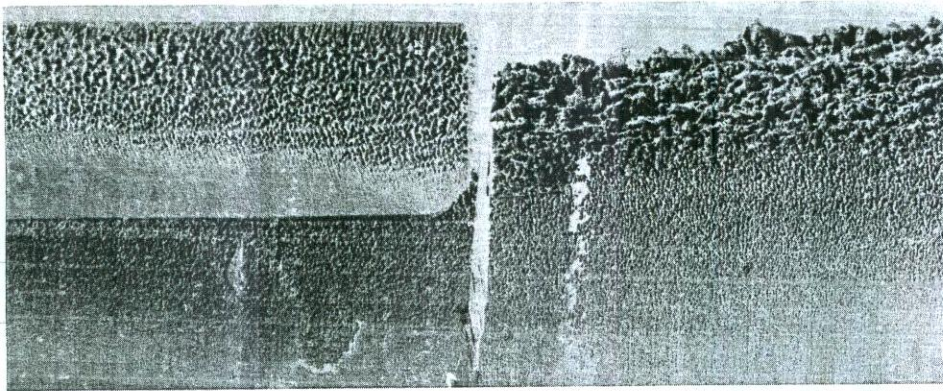
For example, Fig. 12 shows two portions of the leading edge of a blade from the last stage of a low-pressure steam turbine. One portion (at left, Fig. 12) was protected by an erosion shield of Stellite 6B; the other portion (at right, Fig. 12) was unprotected type 403 (modified) stainless steel. The shield made of 1-mm (0.04-in.) thick rolled strip and brazed onto the leading edge, resisted erosion quite effectively, but the unprotected base metal did not.

Both blade portions shown in Fig. 12 also illustrate the dependence of erosion on hydrodynamic intensity. Damage was most severe at the leading edge, where hydrodynamic intensity was greatest. Away from the leading edge, impacting droplets were smaller, impact velocity was lower, and impact occurred at oblique rather than right angles; therefore, damage was progressively less severe. The normal velocity component is important in erosion.

Fig. 12 Two portions of a modified type 403 stainless steel steam-turbine blade damaged by liquid-impingement erosion

The portion at left was protected by a shield of 1-mm (0.04-in.) thick rolled Stellite 6B brazed onto the leading edge of the blade; the portion at right was unprotected. Compare amounts of metal lost from protected and unprotected portions. Both 2.5×
