CRIAQ MANU419 project meeting :

“Water droplets erosion mechanisms of Ti-alloys
used for gas turbine compressor”

PhD – Nelly Kamkar – ÉTS

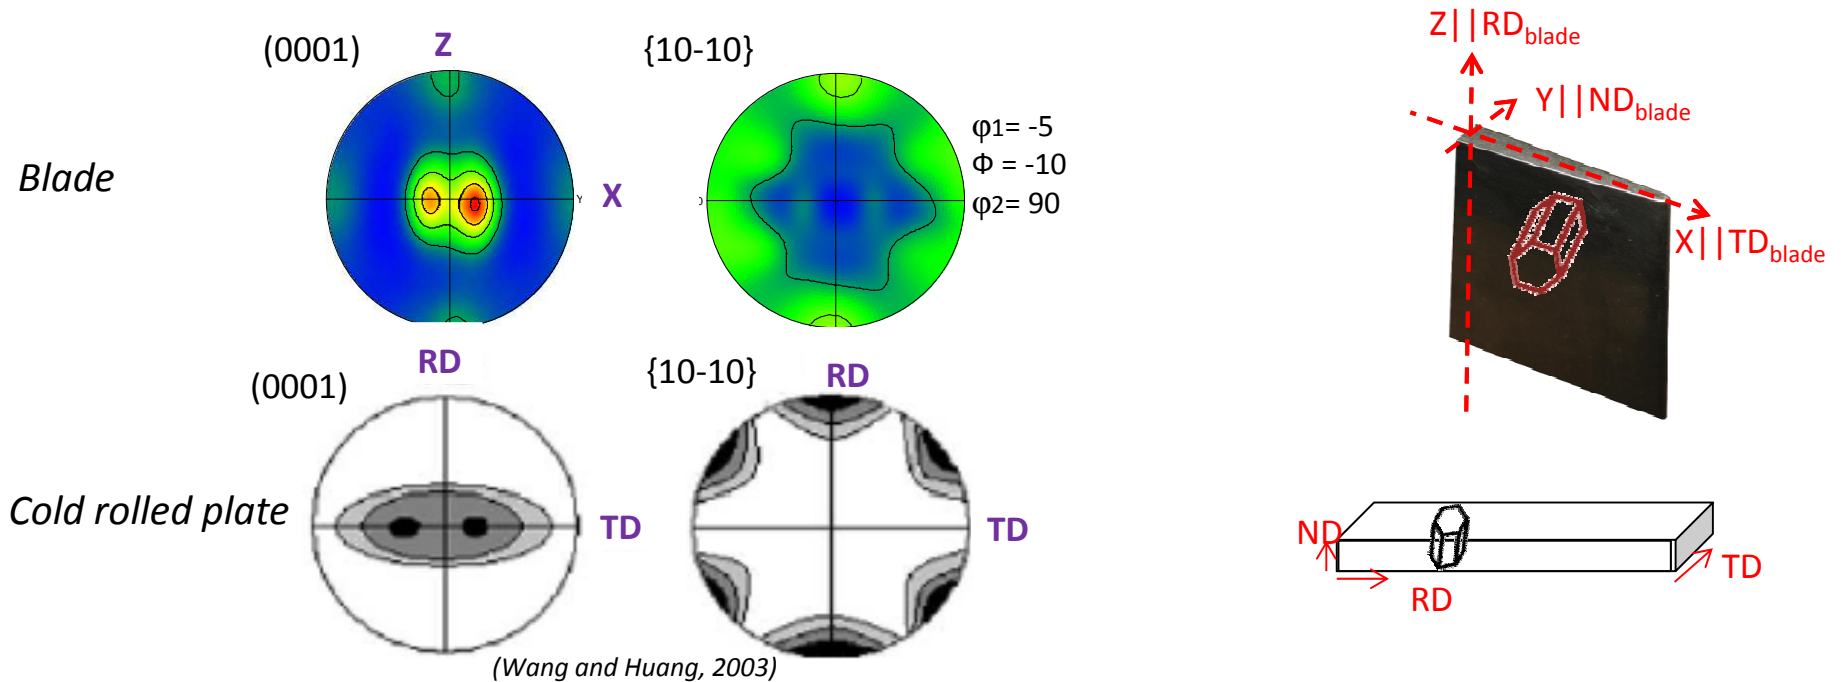
- Cold rolled Ti-6Al-4V texture: basal or nearly basal texture with the poles tilted up to 40° towards TD

➡ Cold rolled plate is selected for base material study

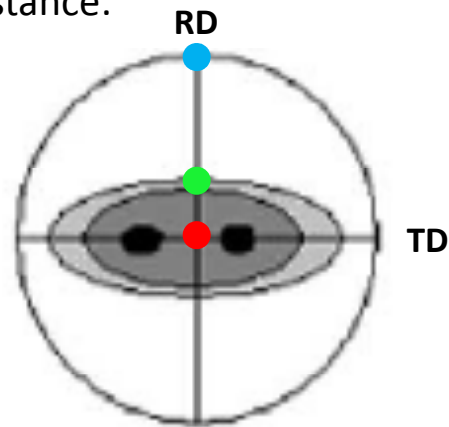
Pole figure

- Experimental plan to investigate influence of crystallographic texture of base material on water erosion resistance:

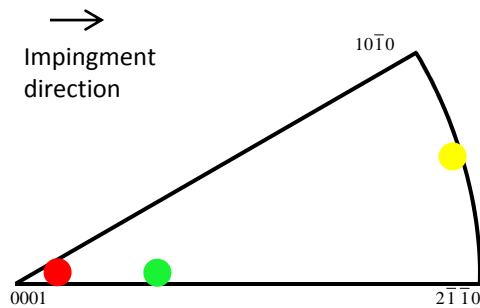
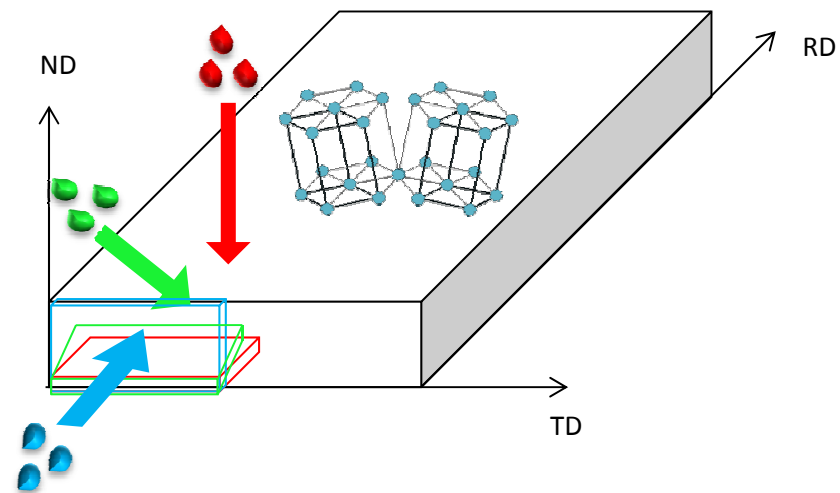
Inverse pole figure

↪ different impingement directions relative to cold rolled plate

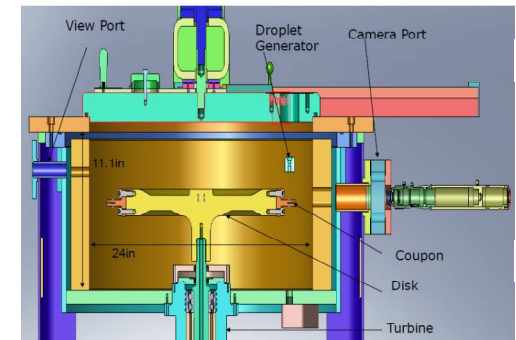
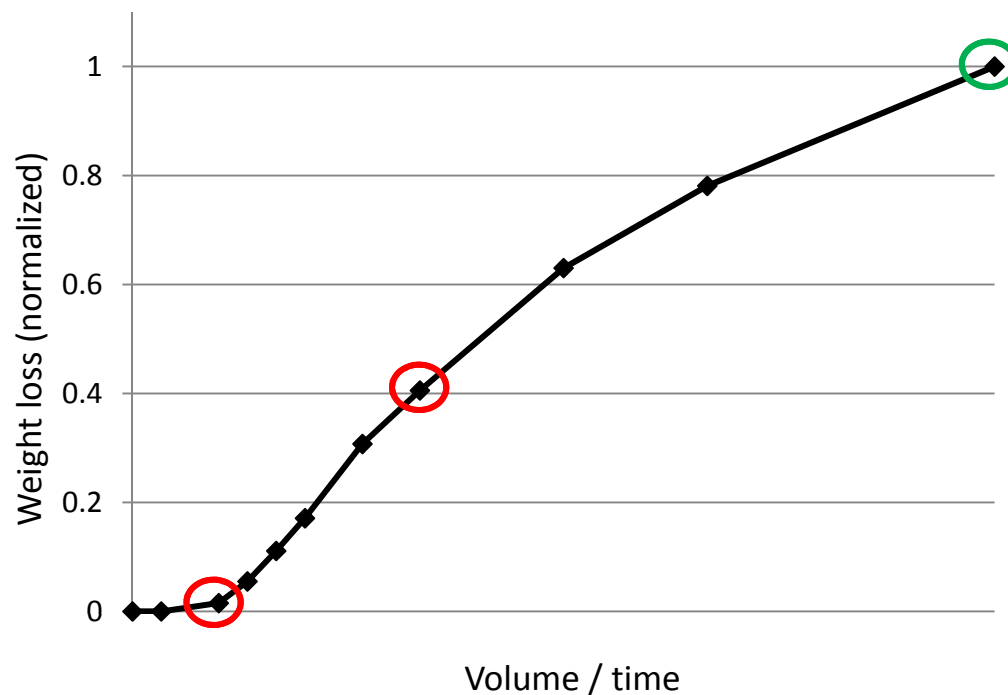
- for each direction of impingement : 3 erosion tests to be run at Concordia (march. - April. 2013)

- ① 1 test until steady state with many interruptions for weight measurement
- ② 2 other tests up to early and intermediate stages of erosion

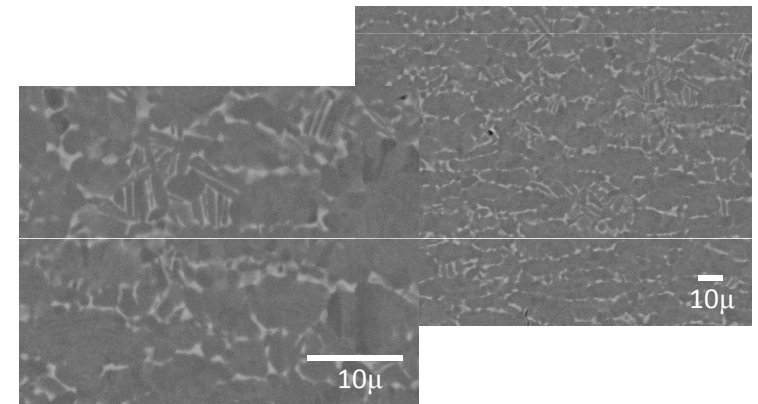
- Base material studies

↳ microstructure at different scale

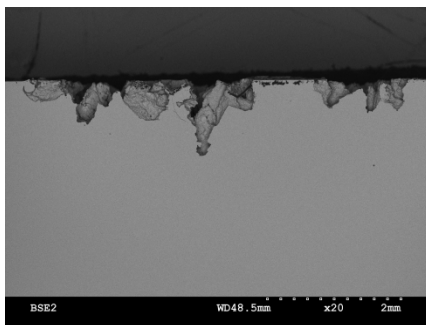
↳ craters formation at macroscopic scale

Average depth

LLP: 575 μ

HLP: 486 μ

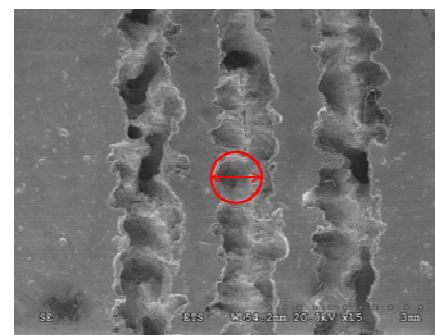
Average width

LLP: 545 μ

HLP: 577 μ

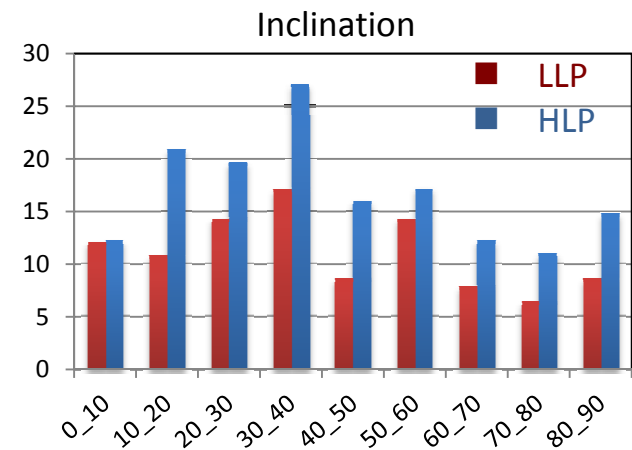
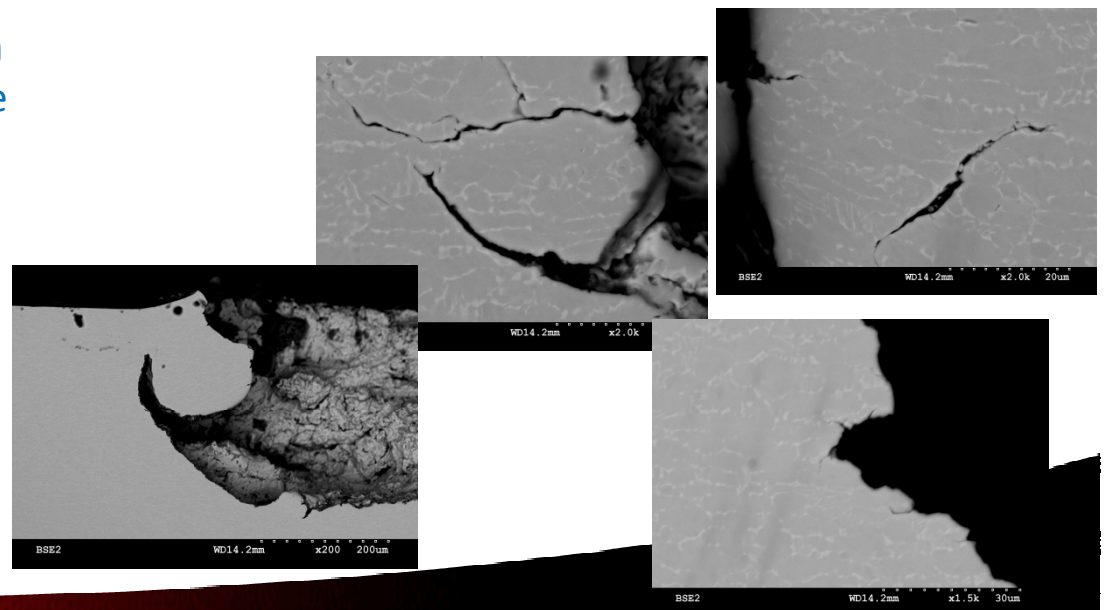
- Observation and specific preparation of cross-section of eroded coupons:

↳ crack size and inclination measurement

- Observation of erosion features:

↳ investigation of erosion mechanism with the focus on surface treated zone
