# Water Erosion Resistance Surface Treatment Using Low Plasticity Burnishing(LPB)

Supervisor: Professor Medraj

Date: 2013/10/03

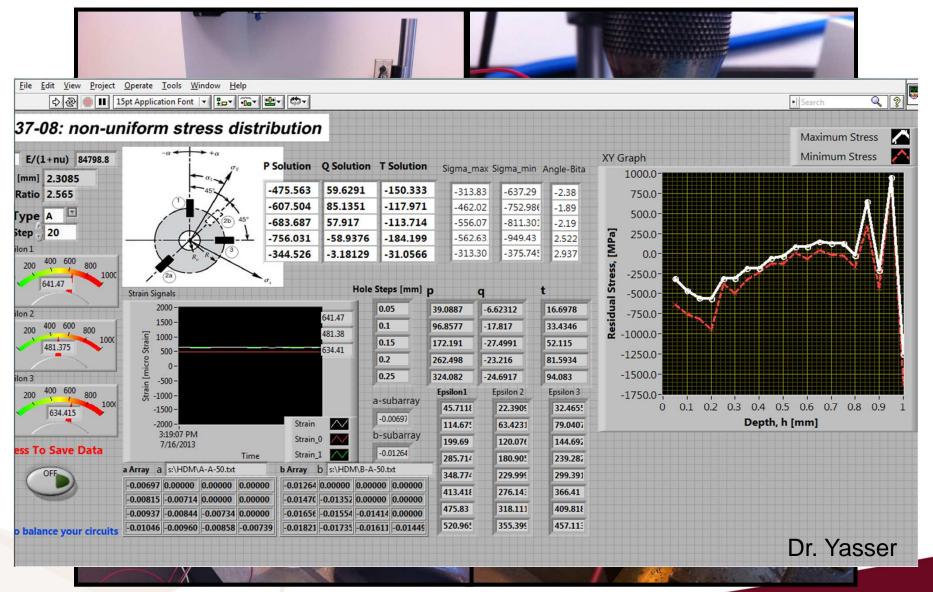
#### Incremental Hole-drilling Residual Stress Measurement

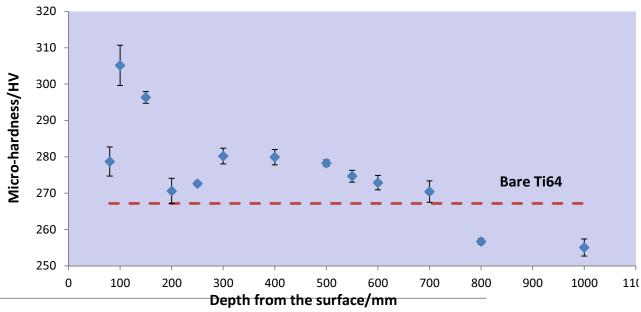
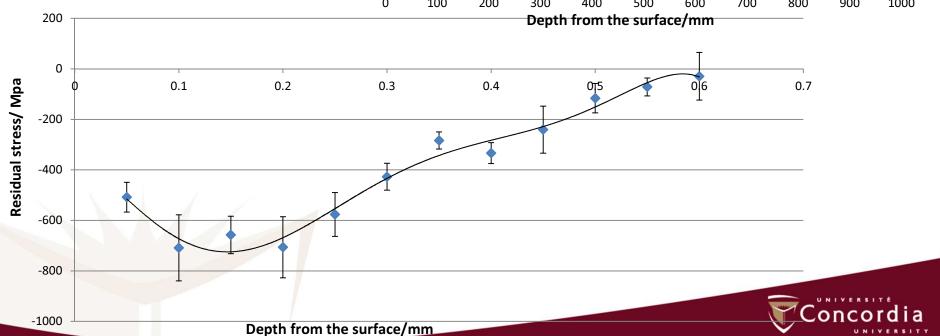
### Residual stress distribution

• LPB sample #6 (+ - - +)

Spindle velocity: 150rpm

Feed: 0.06mm/rev

#Passes: 1

Pressure: 200 bar

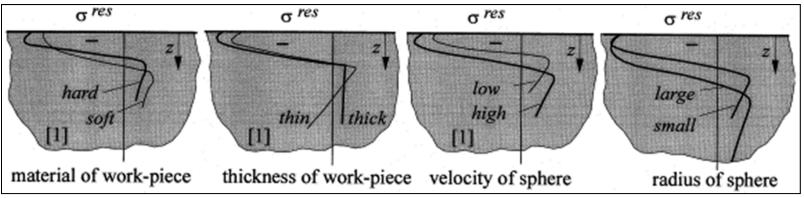
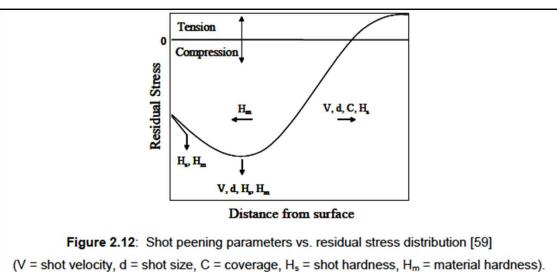
#### Residual Stress Distribution

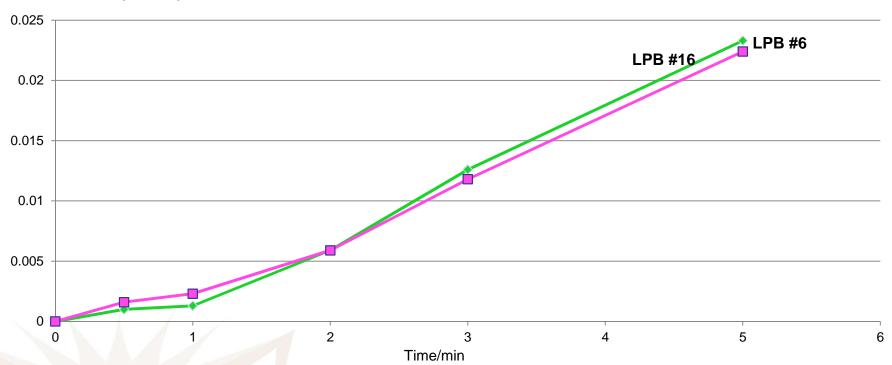
Parameters of LPB sample #6

Spindle Velocity: 150rev/min Feed: 0.06mm/rev

#Passes: 1 Pressure: 200 Bar

Parameters of LPB sample #16

Spindle Velocity: 150rev/min Feed: 0.20mm/rev

#Passes: 1 Pressure: 100 Bar

#### Accumulated Weight loss/g

Droplet size: 600 microns

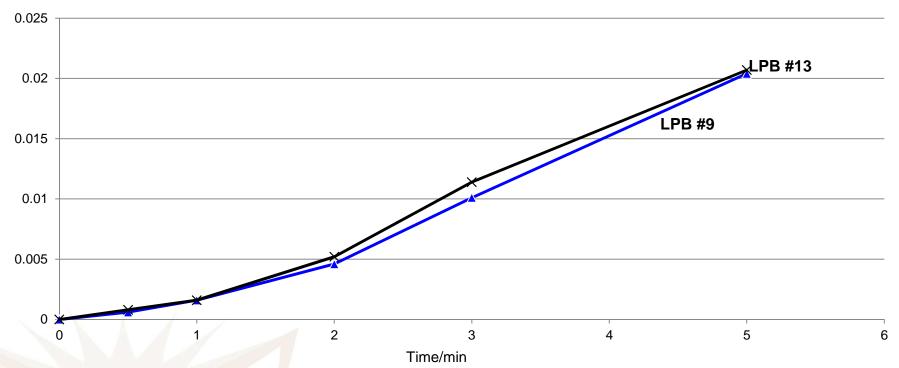
Parameters of LPB sample #9

Spindle Velocity: 75rev/min Feed: 0.20mm/rev #Passes: 3 Pressure: 200 Bar

Parameters of LPB sample #13

Spindle Velocity: 150rev/min Feed: 0.20mm/rev #Passes: 3 Pressure: 100 Bar

#### Accumulated Weight loss/g

Droplet size: 600 microns

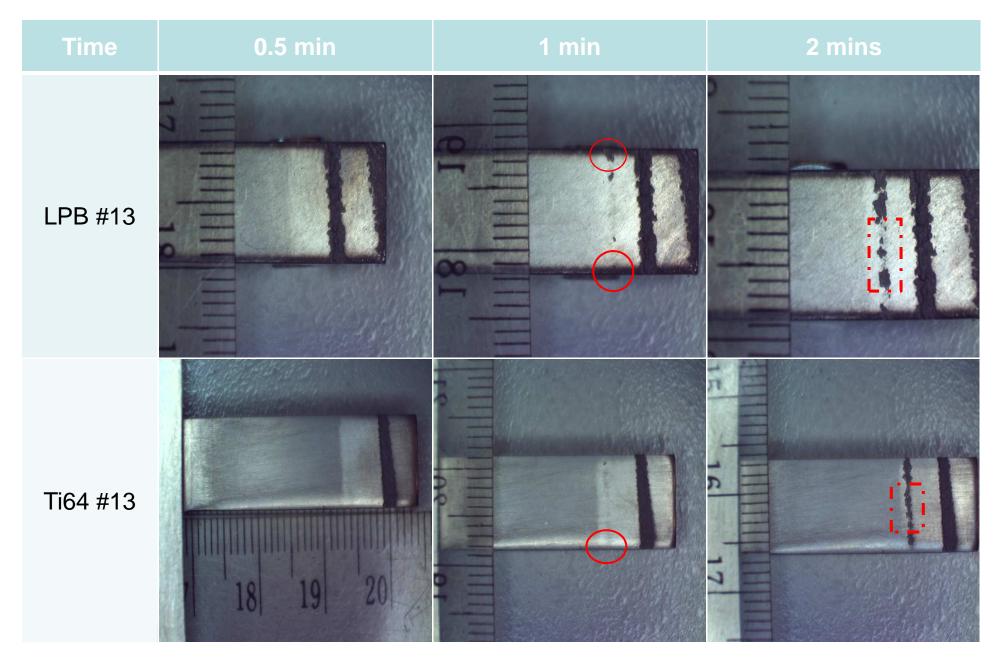
### **Erosion Surface of Test 1**

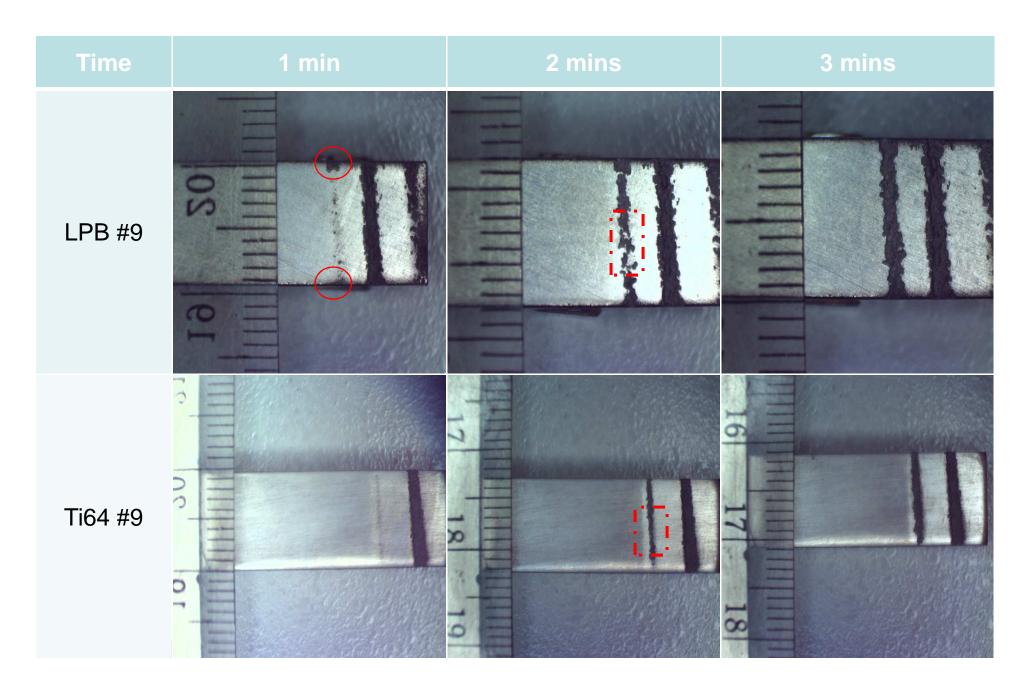
### **Erosion Surface of Test 2**

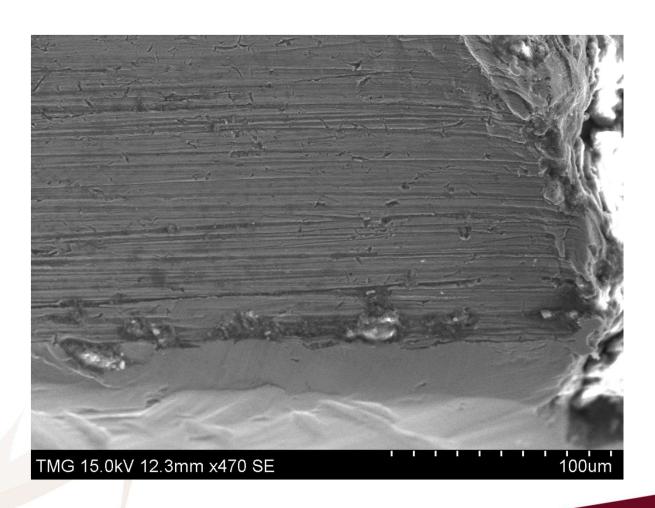
# SEM image of Ti64 edge

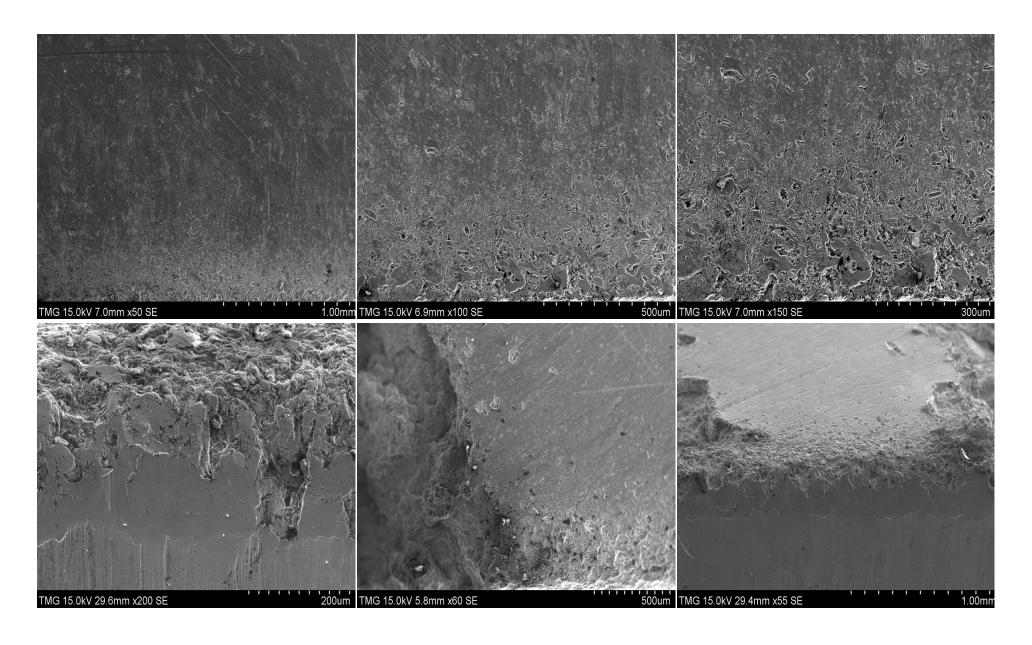
#### SEM image of the Water Jet Cutting Edges of LPB Coupons

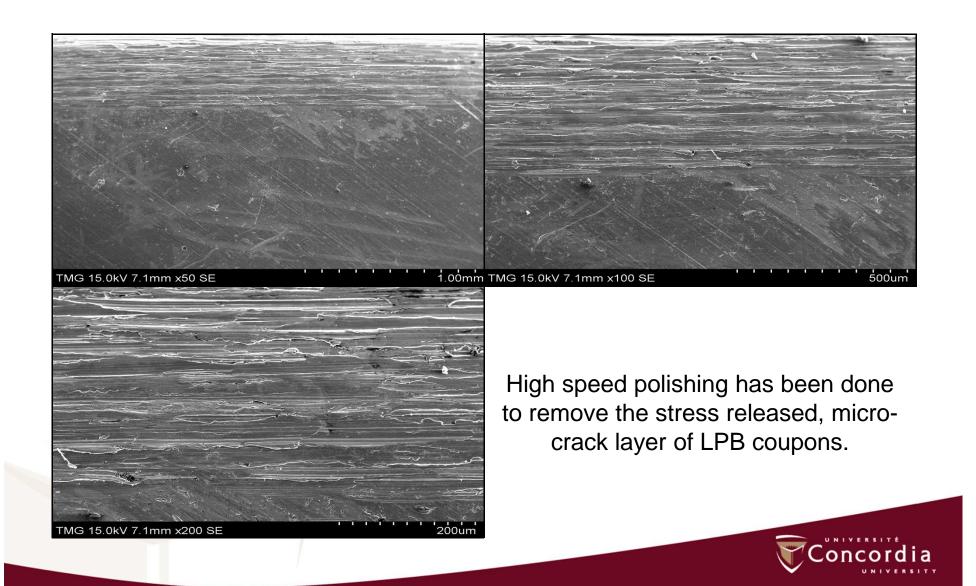
### SEM After Polishing the Edges of LPB Coupons

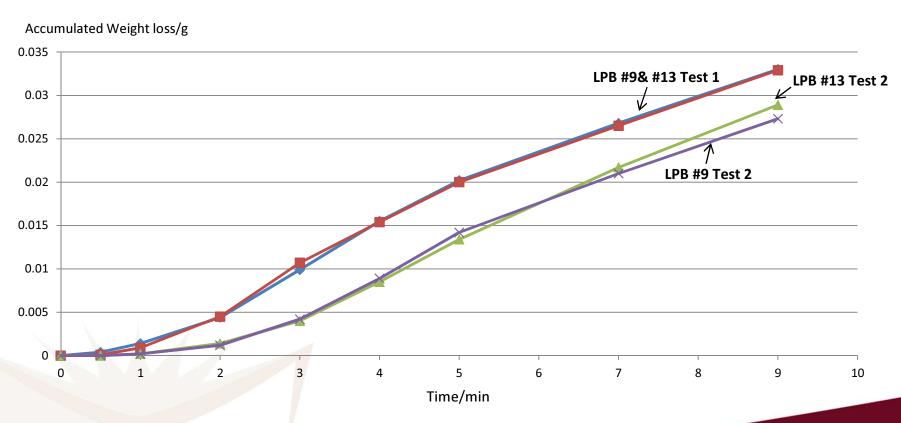
### LPB Test1 Vs. LPB Test2

#### Water Erosion Weight Loss Vs. Time

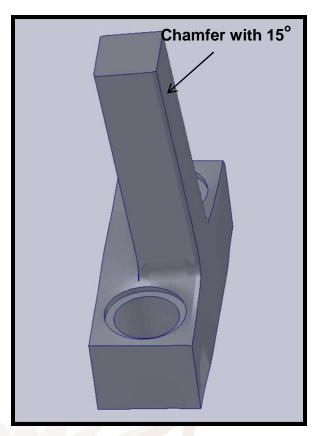
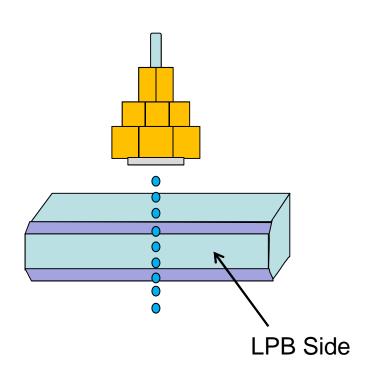
# Solution For Water-jet Cutting Edges

Safety factor = 2.3

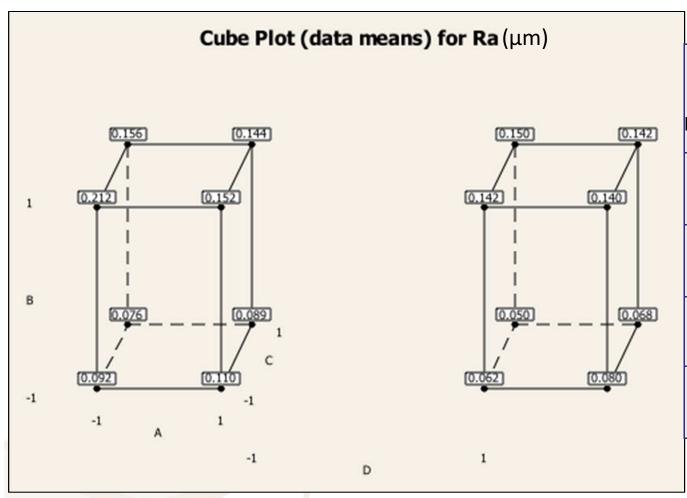
### Surface Roughness Ra Vs. Incubation Period

Levels Factors	High(+1)	Low(-1)
A: Spindle Velocity(r/min)	150	75
B: Feed(mm/r)	0.20	0.06
C: No. of passes	3	1
D: Pressure(bar)	200	100

Surface roughness (Ra) of bare Ti64 before LPB: 0.457µm

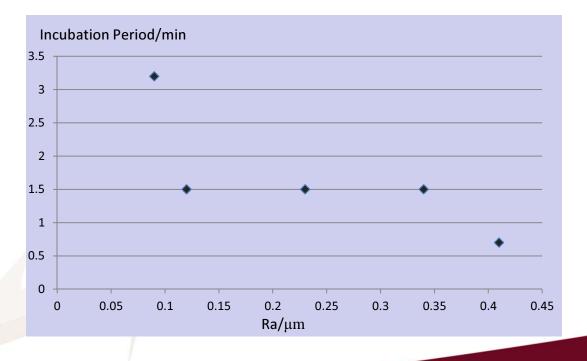
### Ra Vs. Incubation Period

Grinding Grit	#120	#180	#800	#1200	#3 µm
Average Ra/µm	0.43	0.34	0.23	0.12	0.09
Incubation Period/min	0.7	1.5	1.5	1.5	3.2

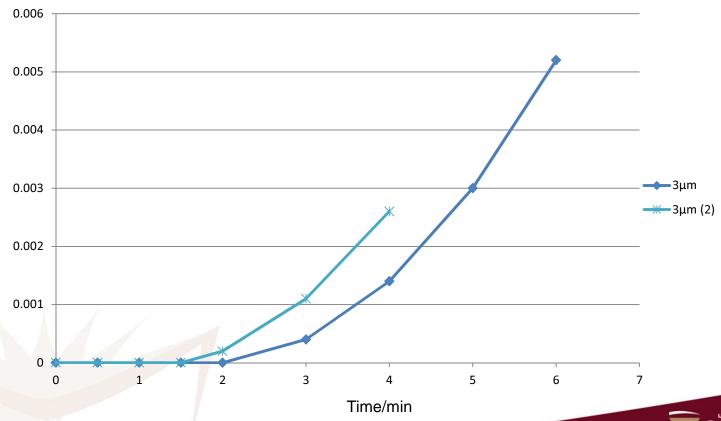
# Repetition of the water erosion test for surface roughness effect study

#### Accumulated weight loss/g
