SAMPLE QUESTION – MECH 321

For the following scenario, explain how and why the component failed. If necessary suggest how failure could have been prevented.

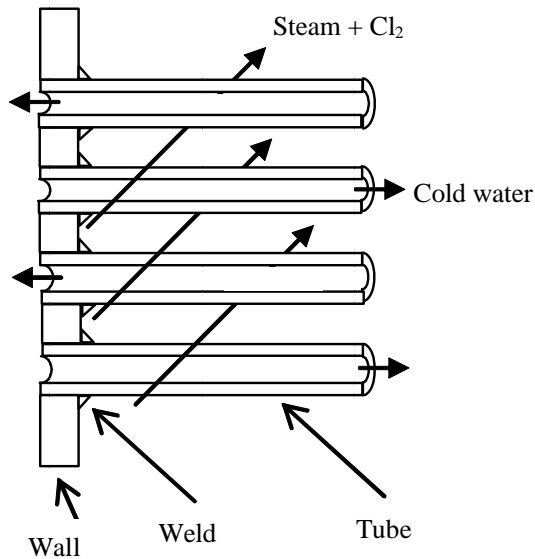
- a) A heat exchanger comprising a bank of tubes welded between endplates as shown in the figure below, has cold water flowing through the tubes and steam (containing chlorine) flowing around the outside of the tubes. The tubes and endplates are made from 304 stainless steel. After several months of operation, several of the tubes have failed in the vicinity of the welds. The fractures show a brittle-type of failure with no or little plastic deformation and when the microstructure near the weld failures is examined it looks like the figure shown below.
