HYDROGEN EMBRITTLEMENT SUSCEPTIBILITY OF Zn-Ni BRUSH PLATING PROCESS

Abstract— Corrosion is one of the most important issues in the aerospace industry and the production of the components of an aircraft. Therefore, certain components of an aircraft are coated in order to provide adequate corrosion protection in service. One of those components is the landing gear of an aircraft which can be protected using either Cadmium or Zn-Ni electroplating. However, one of the major issues associated with this process is the possibility of hydrogen embrittlement (HE) of the base metal. Zn-Ni brush plating is commonly used in aerospace industry for on-site repair of localized coating damage. Thus, in order to evaluate the HE of base metal (SAE 4340 steel) after Zn-Ni brush plating, a 200-hour sustained load test as per ASTM F519 of plated notched specimens was conducted. The results indicate considerable hydrogen embrittlement in the case of non-baked samples while baking even at a temperature of 100°C, which is a significantly lower temperature than the industry standard of 190°C, alleviated the embrittlement. Sand blasting before plating was also found to have a considerable influence in the

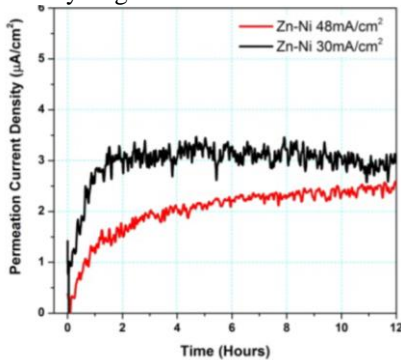
Figure 2- Hydrogen permeation transient for the two Zn-Ni coatings [22]

The morphologies were evidently different as the coating that was plated at 48 mA/cm² had visibely smaller platelets of around 1 µm while the one coated at 30 mA/cm² had platelets ranging from 5-10 µm. Both coatings also had intermittent porosity and micro-cracks. Hydrogen permeability of these coatings was also studied using a Devanathan-Stachurski cell [22]. Figure 2 shows that the coating done at 30 mA/cm² permeating more hydrogen.

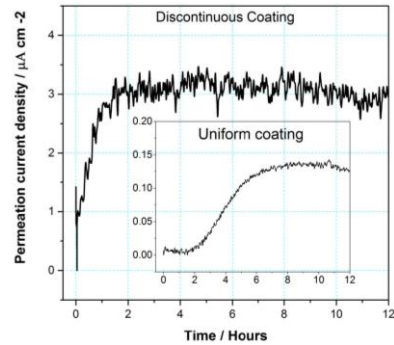
Figure 3- Permeation current densities of uniform and discontinuous Zn-Ni coatings [23]

The importance of micro-cracks and defects were also analyzed by Rajagopalan et al [23] in a similar research. Figure 3 illustrates the diffusion tendencies of hydrogen in a uniform coating compared with a discontinuous coating with micro-cracks and defects. The permeation rate in the discontinuous coating is many orders of magnitude higher

compared to the uniform coating and also reaches its plateau faster. The ease of hydrogen diffusion could be a positive or a negative characteristic depending on the circumstances as it may facilitate significant hydrogen diffusion into the sample during plating or it may allow hydrogen to easily leave the sample during the baking process.
