Influence of Mechanical Surface Treatments on the Water Droplet Erosion Performance of Ti-6Al-4V

A Thesis
In
The Department
Of
Mechanical and Industrial Engineering

Presented in Partial Fulfilment of the Requirements for the Degree of Doctorate in
Philosophy (PhD) (Mechanical Engineering)
At
Concordia University
Montreal, Quebec, Canada

August 2016

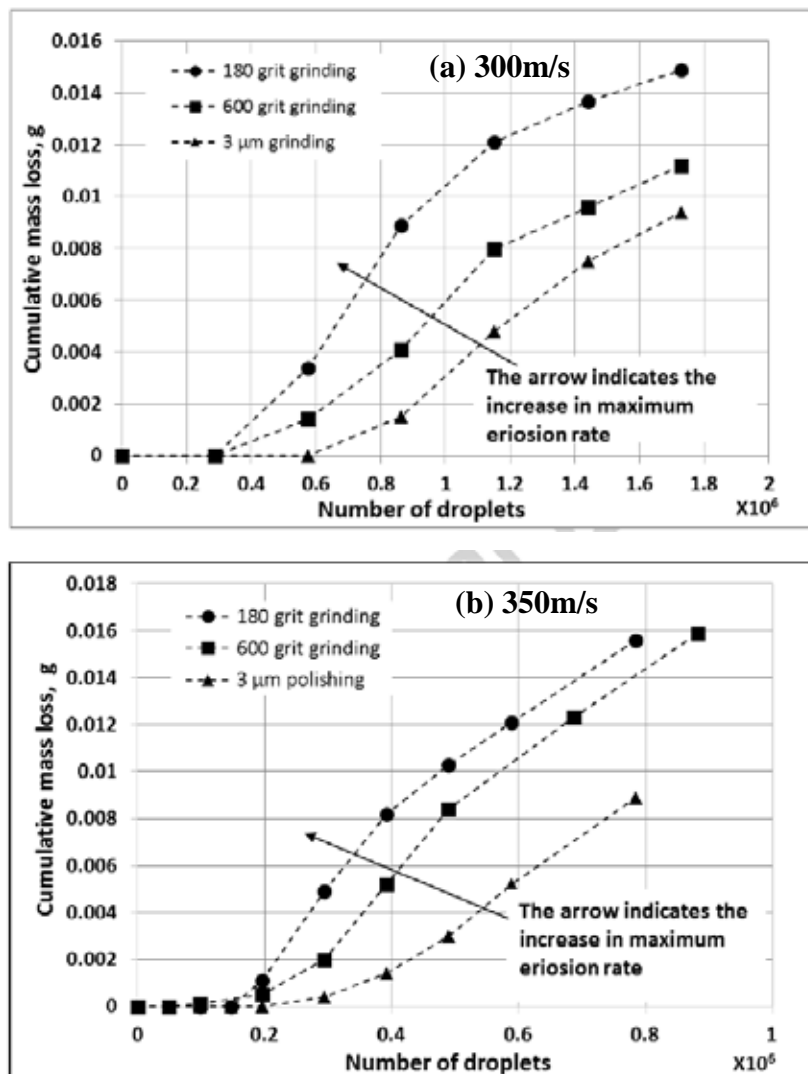
Figure 2-4: WDE behaviour of Ti-6Al-4V having three surface conditions tested at (a) 300 m/s and (b) 350 m/s using 464 μm droplet size [17].

It has been reported that the presence of surface asperities or irregularities prior to erosion test accelerates the erosion initiation [30]. Kirols *et al.* [17] studied the effect of initial surface roughness on the WDE behaviour of Ti-6Al-4V. Ti-6Al-4V samples with average initial surface roughness values (Ra) of 0.30, 0.12 and 0.04 μm were tested. During WDE tests, impact speed of 300 and 350 m/s and droplet size of 464 μm were employed. Figures 2-4a and b show their [17] WDE curves.

Impact speed is one of the most important parameters that influence the WDE behaviour of Ti-6Al-4V. For instance, from Figures 2-4a and b, reducing the impact speed from 350 to 300 m/s delayed erosion initiation and reduced the erosion rate. In another study, Kamkar [9] reported the influence of impact speed on the WDE behaviour of Ti-6Al-4V. Impact speeds of 250, 300 and 350 m/s were employed. Figure 2-5 shows the cumulative mass loss *versus* impingement number. Also, it can be seen in Figure 2-5 that increase in impact speed corresponds to faster erosion initiation and greater erosion rate. However, in this work [9], x-axis was not represented accurately because the number of droplets impacting the sample was not taken into account. Instead, the number of impingement is simply taken as the number of sample rotations. Thus, the information presented in [9] underestimates the number of impingements to erosion initiation. More information regarding the number of droplets impacting the sample is needed for better understanding and representation of test data. This has been addressed in the current research through the use of a high speed camera in order to capture the number of droplets impacting the surface.

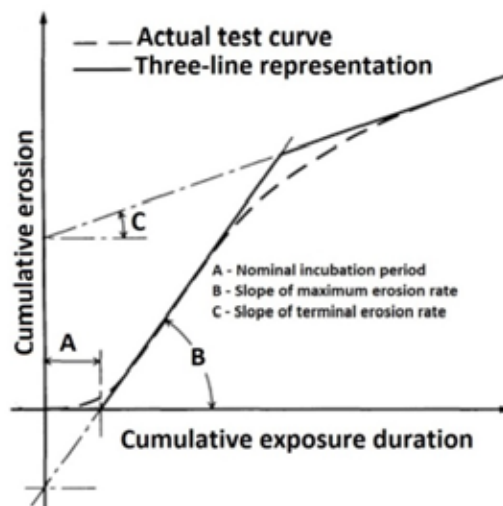
Figure 3-4: Typical three line representation for WDE curve characterization [12].

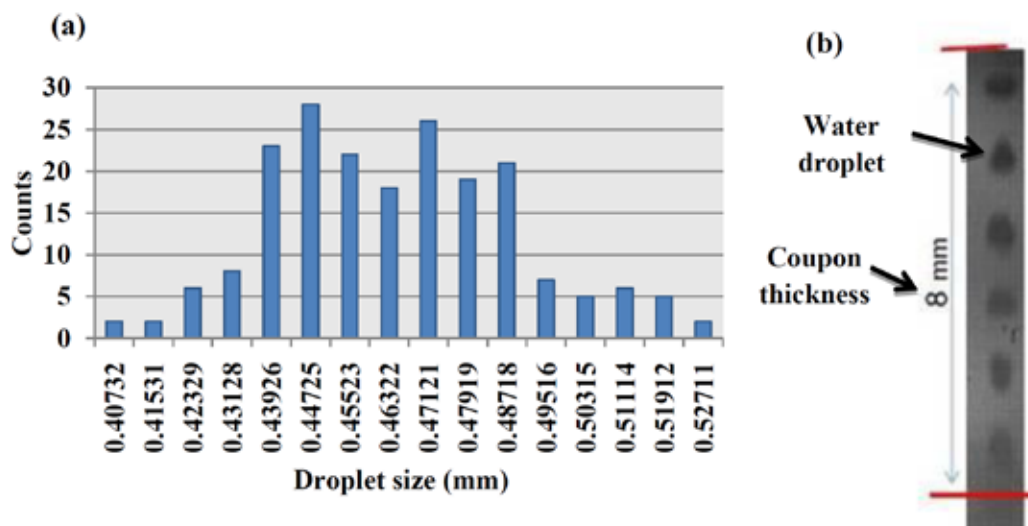
Figure 3-5: (a) Statistical distribution of droplet size range and (b) equivalent number of droplets hitting the coupon.

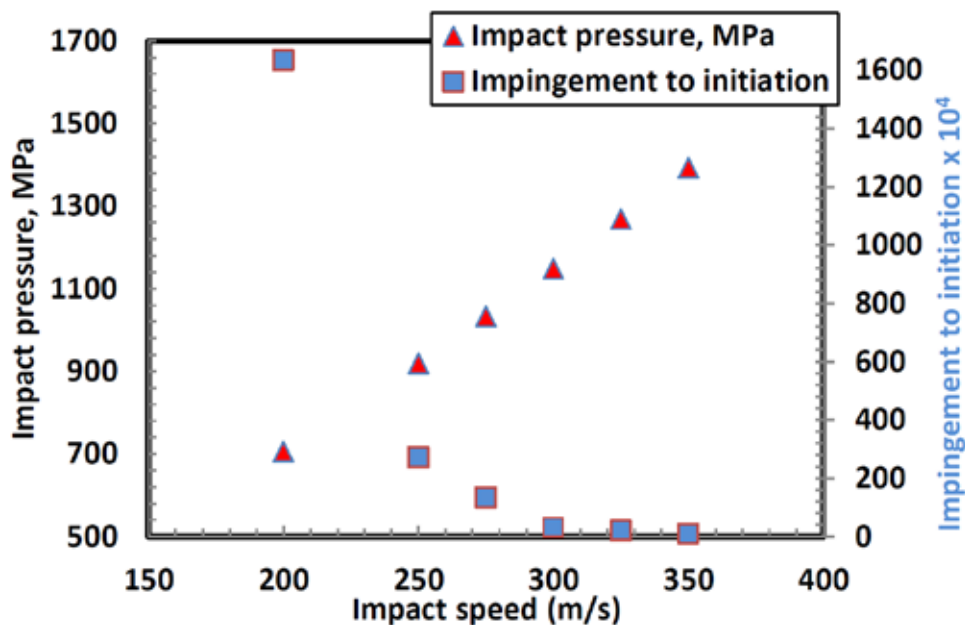
Figure 3-7: Relationship between impact speed, impact pressure and erosion initiation.

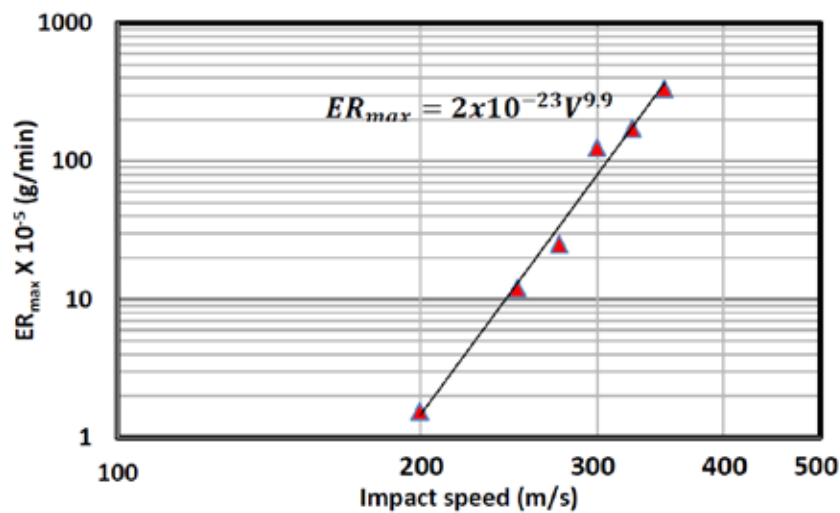
Figure 3-8: Log-log graph of ER_{max} versus impact speed.

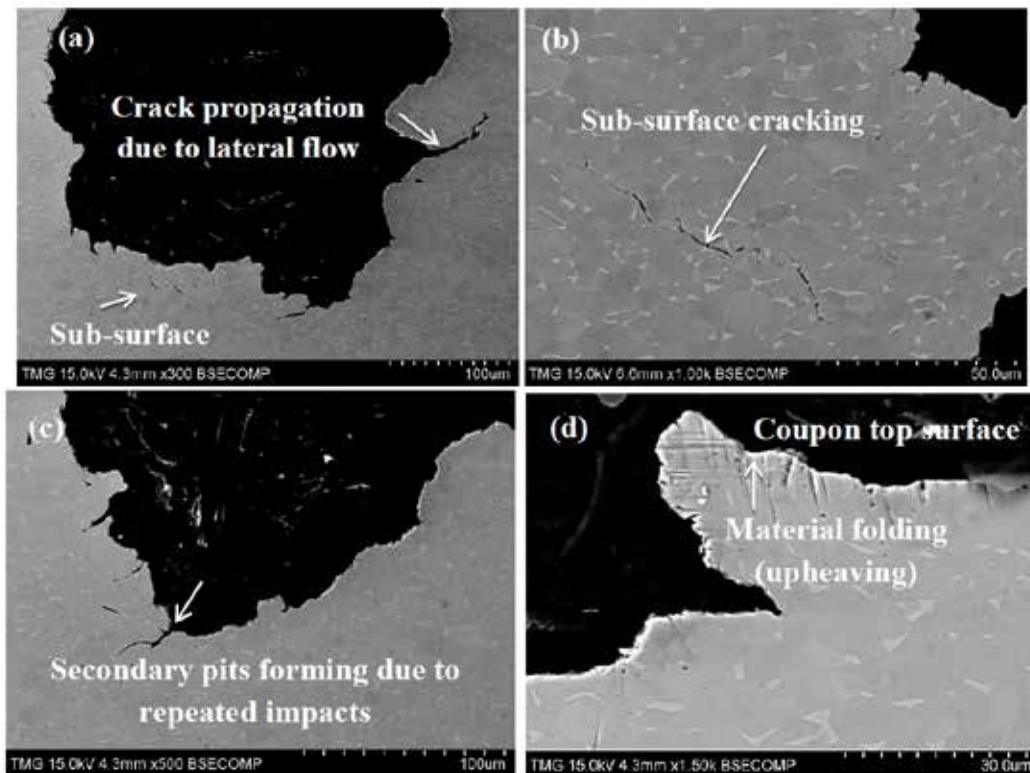
Figure 3-17: Erosion crater showing (a) sub-surface cracks and propagation on the sidewall and base, (b) sub-surface cracking (c) secondary pits formation due to high cumulative impacts, and (d) material upheaving/folding.

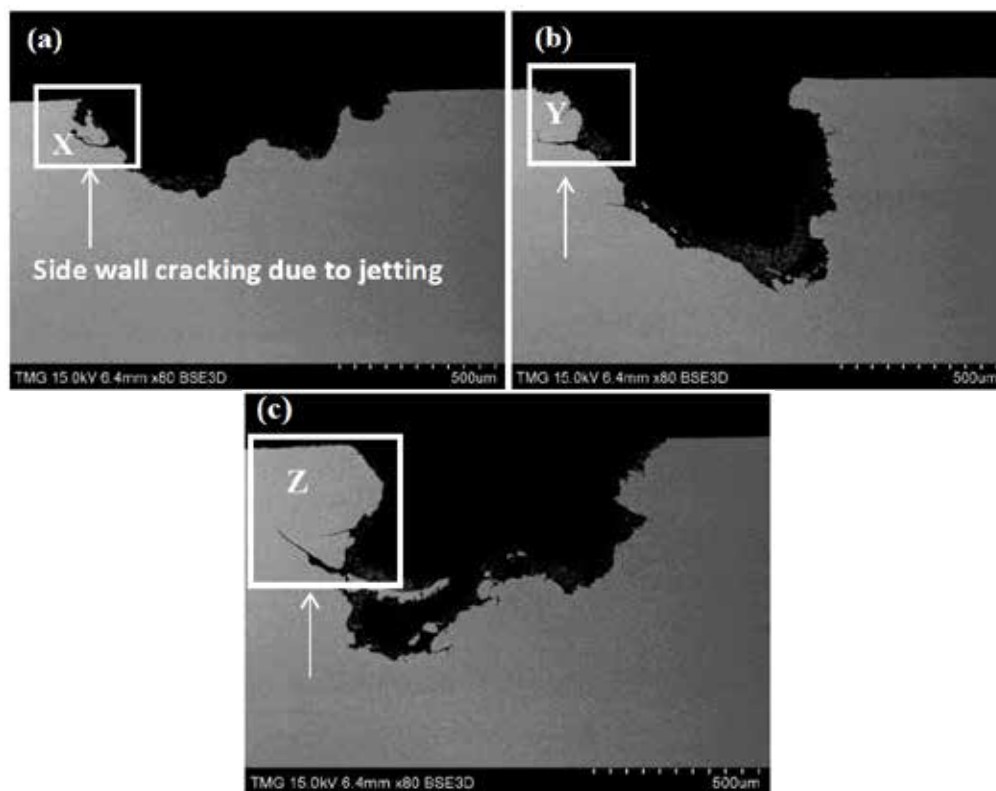
Figure 3-18: SEM micrographs showing craters at (a) 250 m/s (b) 300 m/s and (c) 350 m/s.

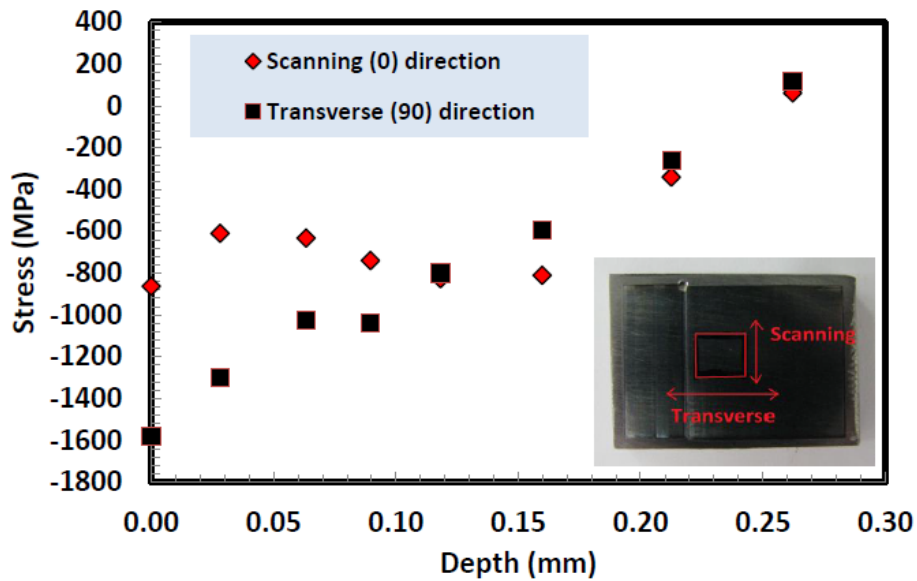
Figure 4-6: Variation of top surface and in-depth compressive residual stress profile.

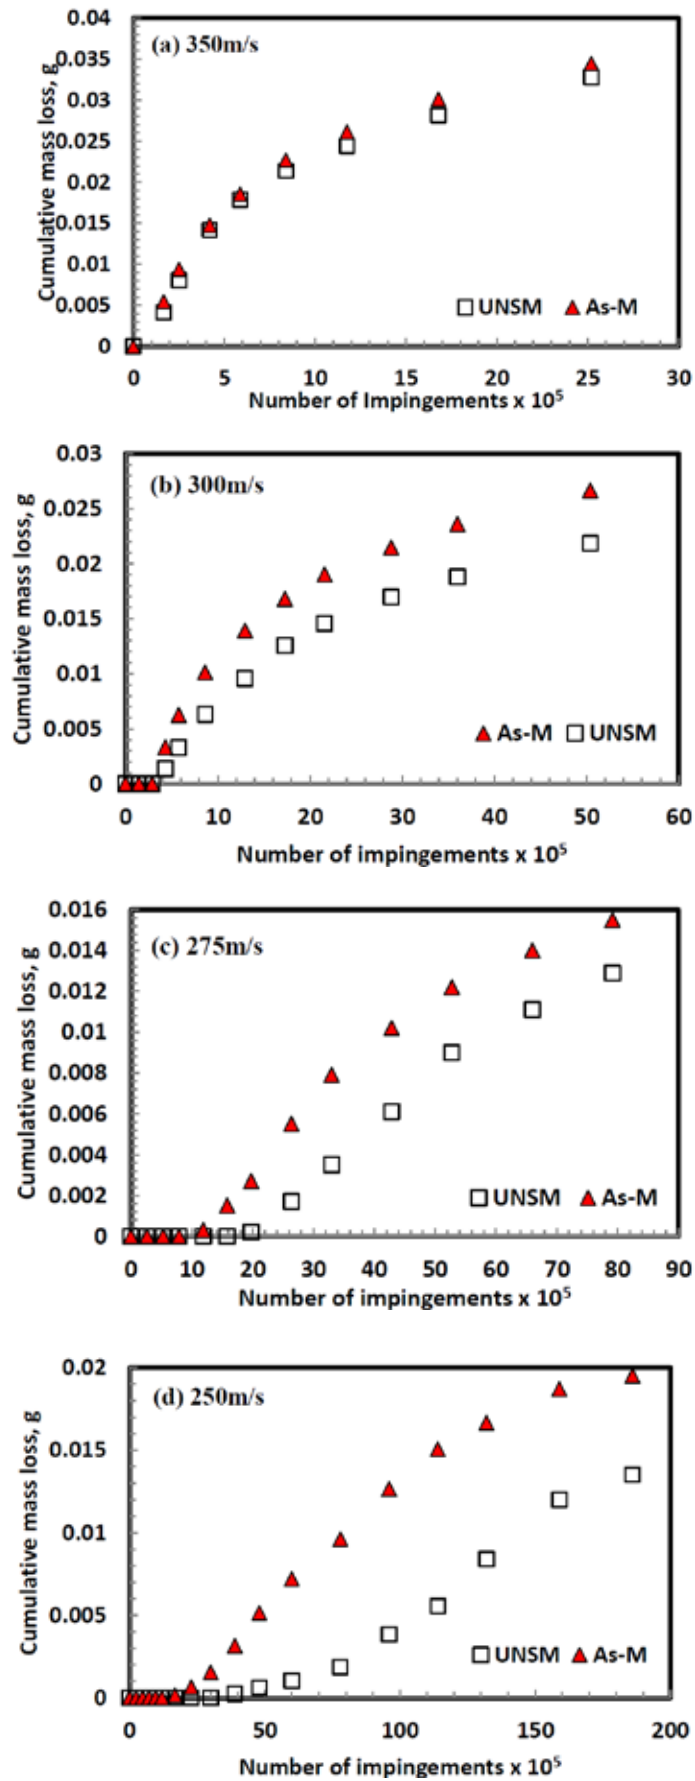
Figure 4-12: WDE curves of As-M *versus* UNSM flat samples at different impact speeds.

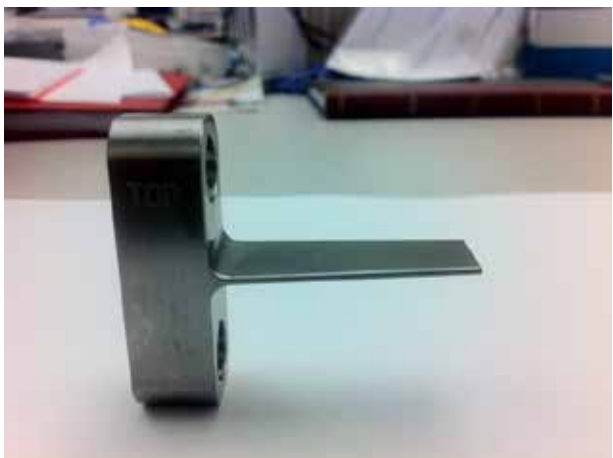
Figure B-2: Airfoil Ti-6Al-4V sample geometry with dimensions in mm.

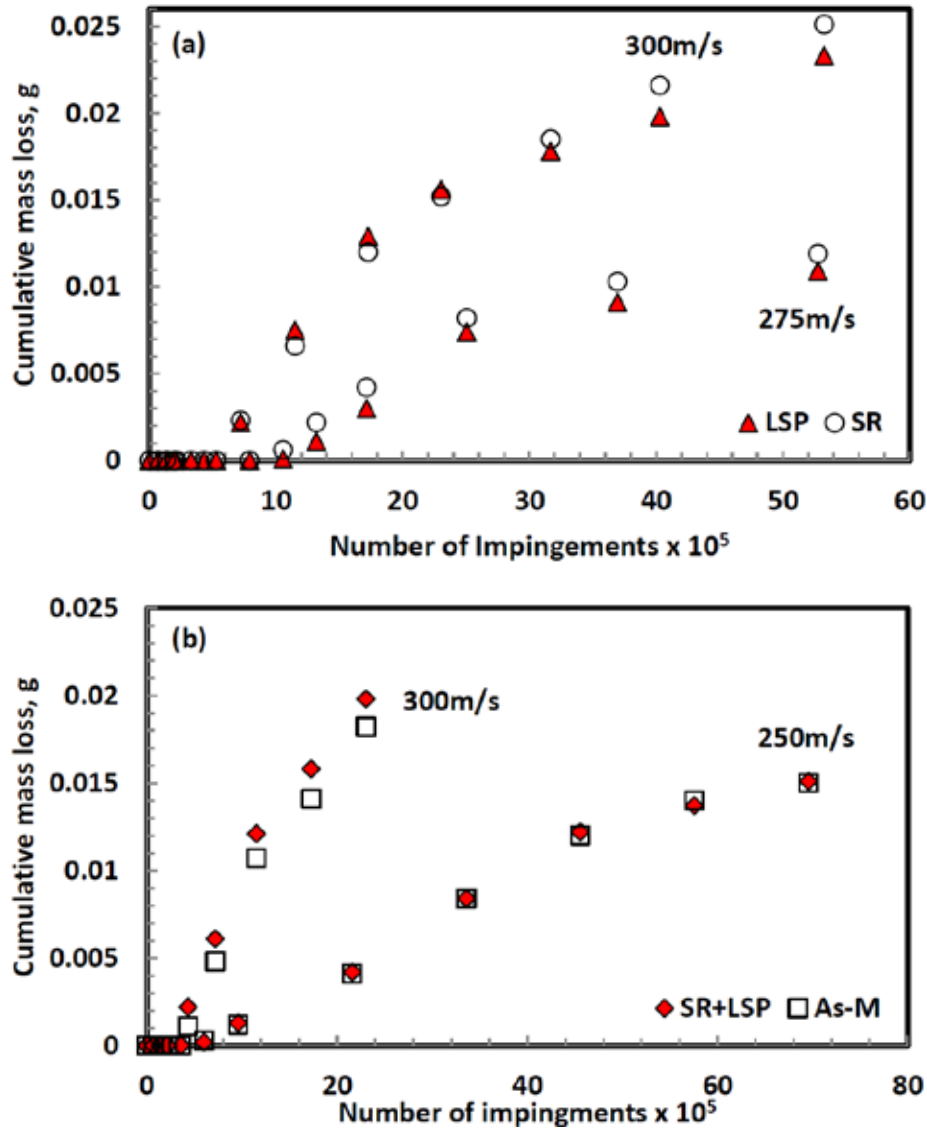
Figure D-1: WDE curves for (a) SR versus LSP at 275 m/s and 300 m/s and (b) SR+LSP versus As-M at 250 m/s and 300 m/s.

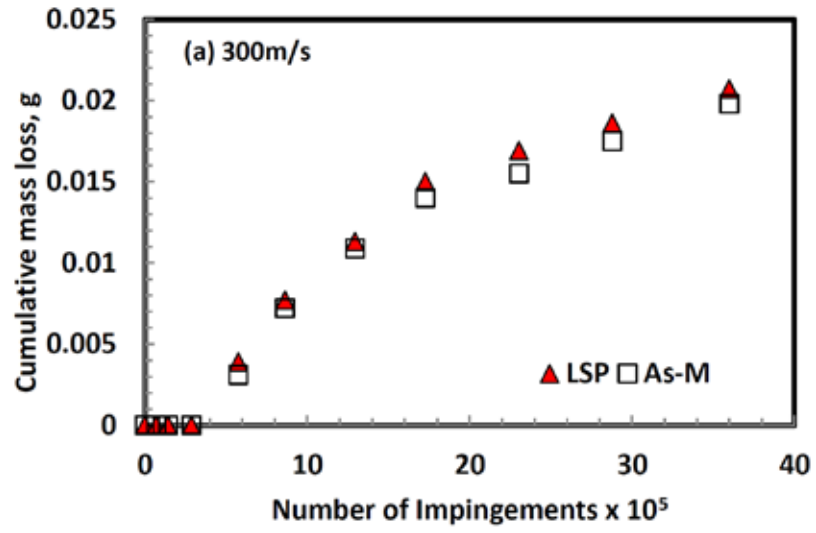
Figure D-2: WDE curve for As-M *versus* LSP conditions at 300 m/s. LSP treatment with low energy laser.
